# Migration of an forgotten intrauterine device into the urinary bladder

Spontaneous migration of the intrauterine devices(IUD) into the bladder is a rare complication. We report and describe the clinical outcome and management of one such case of intravesical IUD. The diagnosis was confirmed after cystoscopic visualization. Endoscopic examination allowed removal of the IUD.

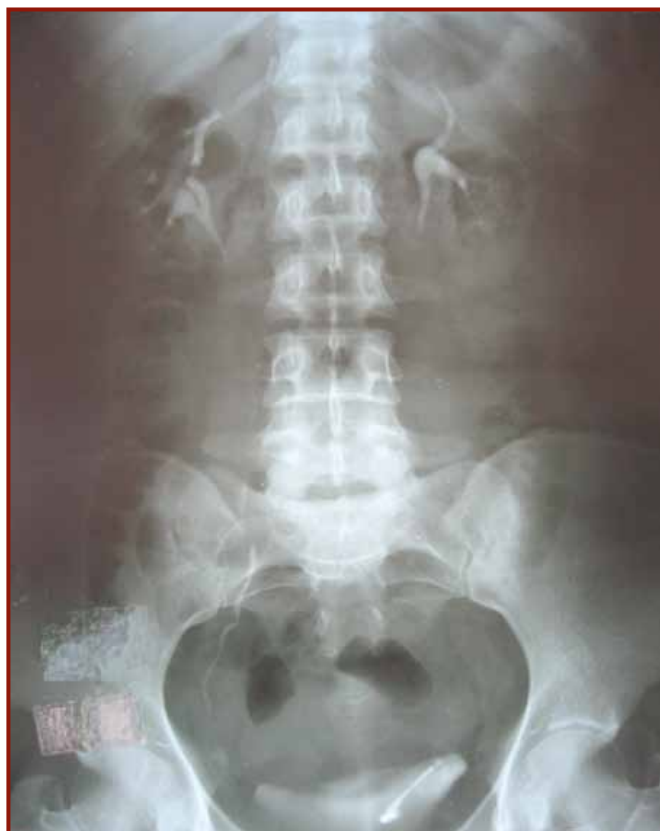
**Figure 1.** IUD overlapping on to the urinary bladder in IVP

The vaginal examination revealed that the IUD was dislocated. Pelvic ultrasonography revealed hyperechogenicity in the bladder wall, which might be consistent with IUD. Intrauterine device was detected in the pelvis via direct pelvic radiography examinations. No pathological findings were established in the abdomen ultrasonography. Intravenous pyelography showed us that the IUD was overlapped over the urinary bladder (Figure 1). Cystoscopic examination under local anesthesia, revealed that the IUD was penetrating the posterior wall of the bladder and was fixed to the bladder wall (Figure 2), not lying free in the bladder with calculus formation surrounding it's body partially. A second cystoscopy was performed under general anesthesia, but the tail of IUD cannot grasped by standard forceps. Then the application was repeated by using nephroscopy shaft and nephrostomy forceps and the IUD was easily removed as a whole unit by pulling it through the perforation site and by the aim of gently taken out through the cystoscope we divided the IUD into two pieces intravesically(Figure 3). A Foley catheter was left in bladder for 5 days. The patient was discharged 3 days after the IUD removal without complication.

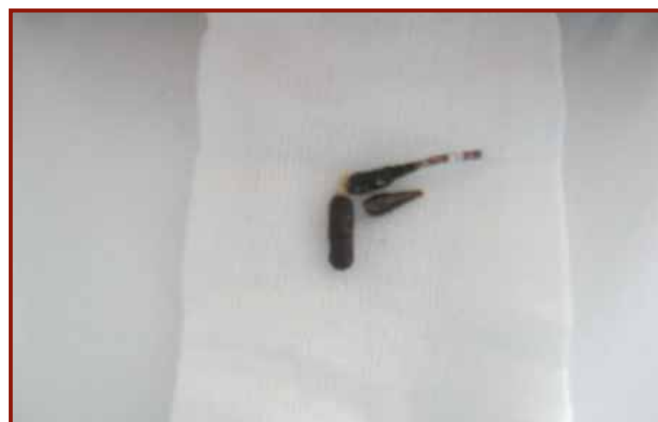
**Figure 3.** Removed IUD (divided)
